DEPARTMENT OF TRANSPORTATION**DIVISION OF ENGINEERING SERVICES**

Contract #: 04-0120F4Cty: SF/ALA Rte: 80 PM: 13.2/13.9File #: 69.28**WELDING INSPECTION REPORT****Resident Engineer:**Pursell, Gary**Address:** 333 Burma Road**City:** Oakland, CA 94607**Report No:** WIR-002004**Date Inspected:** 18-Apr-2008**Project Name:** SAS Superstructure**OSM Arrival Time:** 2300**Prime Contractor:** American Bridge/Fluor Enterprises, a JV**OSM Departure Time:** 730**Contractor:** Zhenhua Port Machinery Company, Ltd (ZPMC), Changxing Island **Location:** Shanghai, China**CWI Name:** An Qing Xiang**CWI Present:** Yes No**Inspected CWI report:** Yes No N/A**Rod Oven in Use:** Yes No N/A**Electrode to specification:** Yes No N/A**Weld Procedures Followed:** Yes No N/A**Qualified Welders:** Yes No N/A**Verified Joint Fit-up:** Yes No N/A**Approved Drawings:** Yes No N/A**Approved WPS:** Yes No N/A**Delayed / Cancelled:** Yes No N/A**Bridge No:** 34-0006**Component:** Tower**Summary of Items Observed:**

Caltrans Quality Assurance (QA) Inspector, Mike Hasler was present to observe the fitup, welding and related activities associated with the fabricating of Caltrans Mock-up, 77M, 89M, 114M, Orthotrop

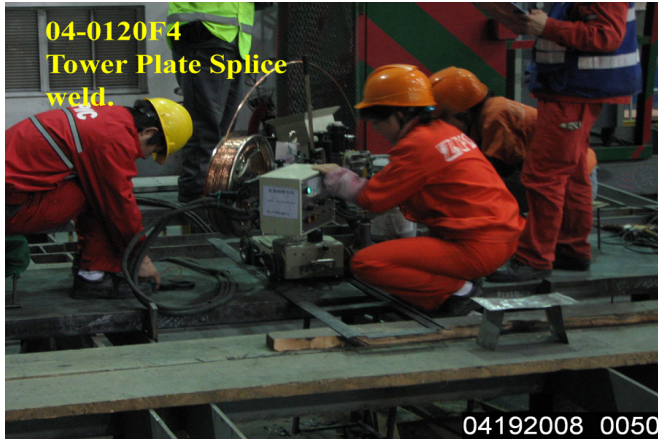
New Tower Shop Bay 1: ZPMC performed submerged arc welding (SAW), tower skin plate splice weld, joining plate P661 (S) to P124 (S) plate. The welder operator is identified as Ms. Xu Yan, welder stamp 052917, utilizing welding procedure WPS-B-T-2221-B-U3c-S-1; weld joint SSD1-SA216 E/G- 10A. Caltrans QA measured current welding parameters at approximately 630 amps, 32.0 volts and 610mm/min (millimeters per minute) travel speed. Caltrans QA verified preheat and interpass temperatures during the welding activities. The preheat temperature prior to the start of welding measures more than 110 degrees Celsius but less than 230 degrees Celsius during maximum interpass temperature verification. Caltrans QA observed ZPMC QC inspector, Mr. An Qing Xiang and ABF Inspector, Mr. Dai Qing Wen monitoring welding activities at the work station. The following digital picture illustrates welding in progress.
